# **Eye Witness Works** Sheffield

## **Design Proposals**

Harrison Fisher & Co

**06-028** May 2007 - Rev 001

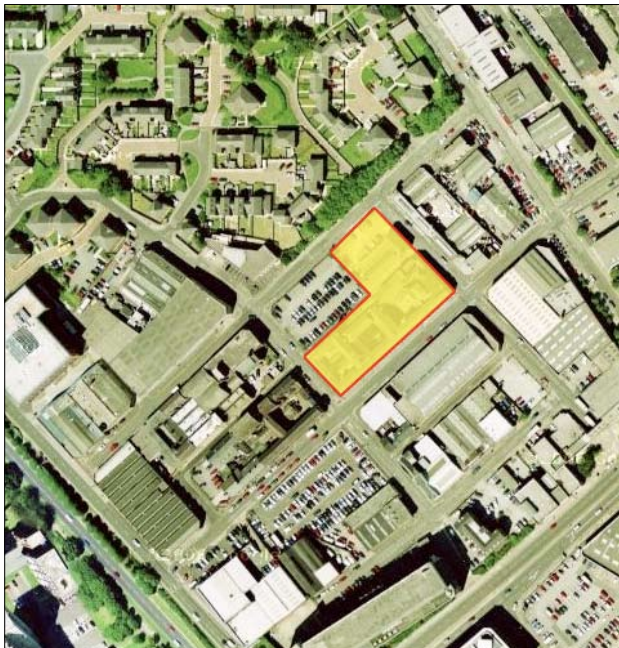
## The Site

This 0.826 acre site spans across what was two separate sites, be it under one ownership; these are The Eye Witness Works and the Ceylon Works. These two sites are separated by Egerton Lane and are bounded to the South by Milton Street and to the East and West by Headsford Street and Thomas Street.

The Eye Witness is a large steam-powered, integrated cutlery works established in the early 1850s. The works were built around three yards in several phases from this date onwards providing offices, warehousing and showrooms to the principle building along Milton Street. To the rear and clustered around the courtyards (which have latterly been filled in) were the workshop ranges containing forges, grinding and buffing.

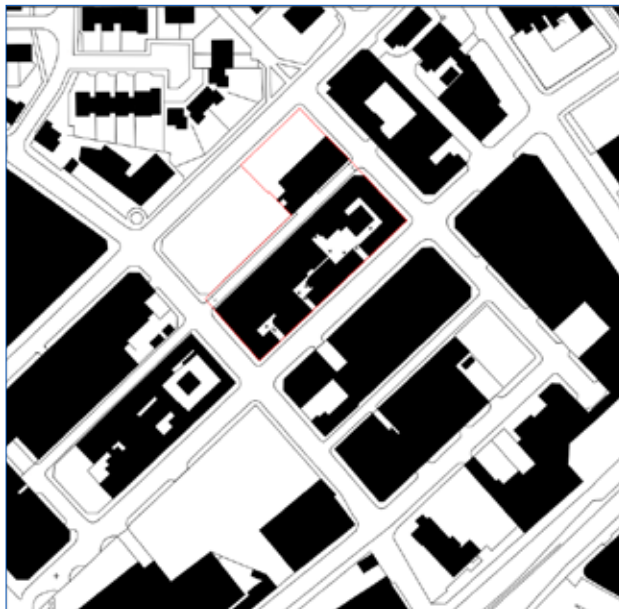
## Figure Ground Study

The blocks within the Milton Street area follow a rectilinear grid pattern. The building footprints follow this pattern and generally are built up to the back edge of the pavement. Whilst the blocks are long they are shallow in depth and the buildings mass is broken down by a series of internal courtyards.

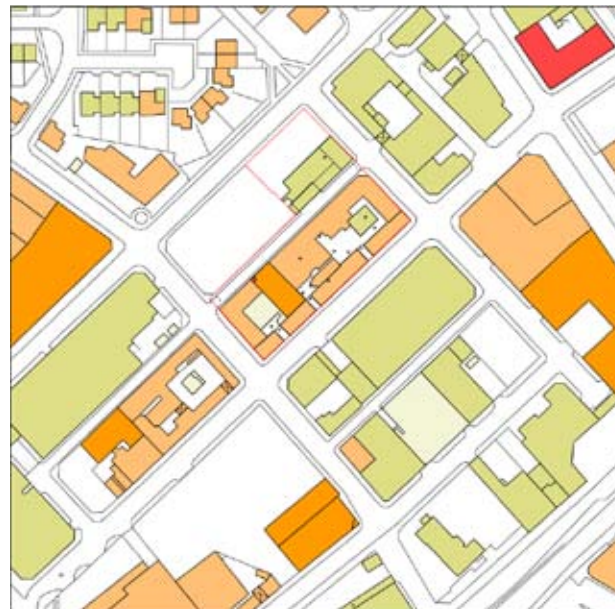
## Building Height

The predominant building heights within this area are 5-8m this has been driven by the predominant industrial use in the area. The area is in transition with a general increase in building heights of 15+m for the newer developments pushing NE towards Devonshire Green South towards Hanover Way.

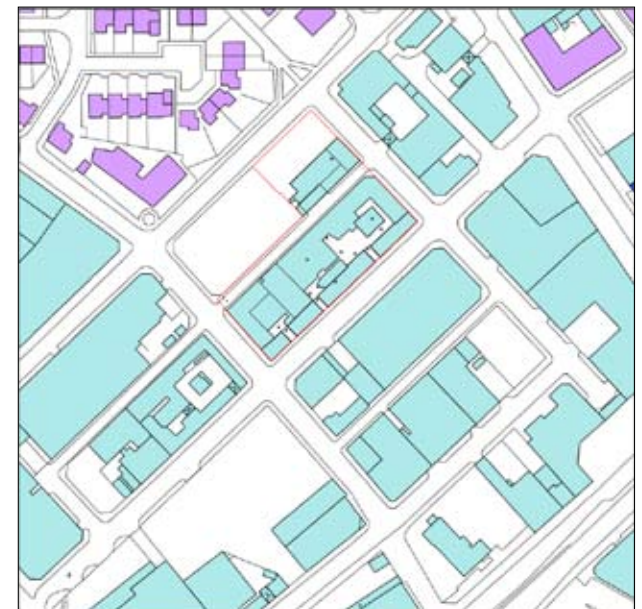
## Land Use

The principle historic land use in this area is for office/ industrial building types. There is a general shift within planning policy allowing new building types to emerge as part of new build and refurbishments. These uses include residential, student accommodation, retail and other commercial uses.

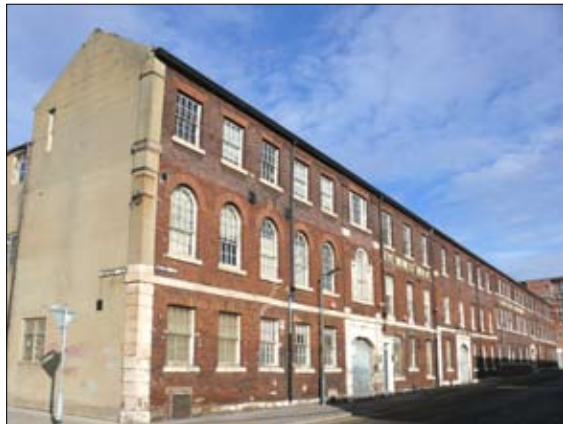
### Milton Street Elevation – Block A

The Principle Frontage along Milton Street was constructed in a series of stages from 1852 through to 1875. This three storey, thirty bay fronted building comprises of four distinct blocks unified under a single double pitched slate roof.

**Architectural:** The principle façade has many features of interest with a first floor plinth, Venetian windows, feature archways to the inner courtyards and extensive use of rustification along its length.

**Structural:** The building has undergone extensive work, principally relating to the removal of some of the internal cross walls and new slates to the roof. There is evidence of some settlement and cracks within the walls but this seems to be historic and does not extend to the later additions.

**Summary:** Whilst the building has had significant alterations it is structurally and materially sound. It is recommended that a full structural survey will be undertaken before any works commence. Architecturally the façade on Milton Street is the principle façade and has many features of historic and architectural interest which should be retained and restored.

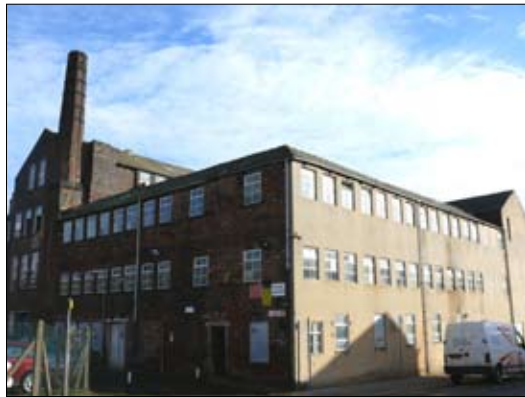
### Headford Street Elevation - Block B

This block seems to be an extension of the Milton Street block and was constructed in the 1850's providing workshop accommodation. This three storey building wraps around the corner onto Egerton Lane and has a double pitched slate roof.

**Architectural:** The façade was originally blank to the lower levels but has had windows inserted at a later stage in an irregular pattern to the window fenestration on the upper levels. The Headford Street elevation is part rendered and there are no architectural features on the exposed brickwork facades.

**Structural:** The brickwork is poor quality, deeply weathered and with a substantial proportion of the bricks spalling. Due to their condition and prevailing winds the brickwork deterioration could not be arrested and as such a render finish has been applied.

**Summary:** The building is in a poor structural and material state, architecturally it has no features of interest. It is recommended that this building be demolished.

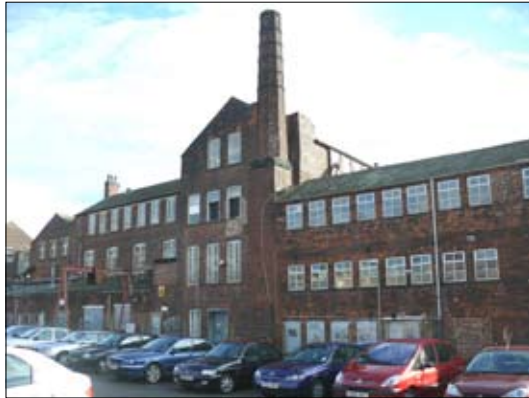
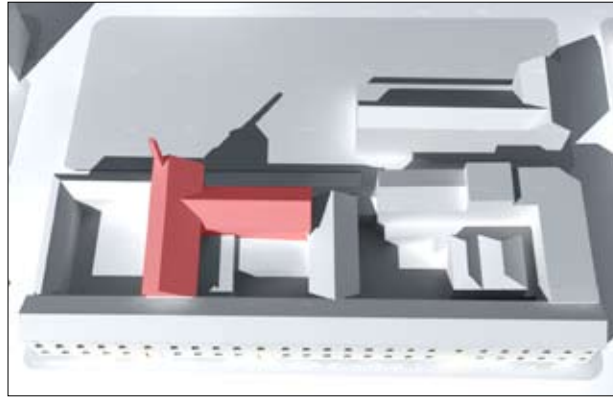
### **Boiler House, Egerton Lane – Block D/E**

Block D was constructed at the same time as block B (circa 1850's) and is a four storey brick built building with a double pitched roof. Set into the West corner of the building is a stone plinth upon which sits an octagonal brick stack rising to 60 ft high. Block E was constructed at about the same time as block D but is separate in terms of its planning and floor levels.

**Architectural:** The facades to these buildings are brick clad with inset casement windows, these give the building a simple symmetry. It is the adjacent chimney that gives the building its architectural quality and interest.

**Structural:** Whilst both blocks D/E are structurally sound, due to the extensive remodelling and different floor levels any proposal will be structurally difficult.

**Summary:** Whilst it is recommended that they are retained due to architectural quality and positive contribution to the urban grain and massing a full structural survey will be required to understand the extent of structural integration that these elements have with the main blocks to be retained.

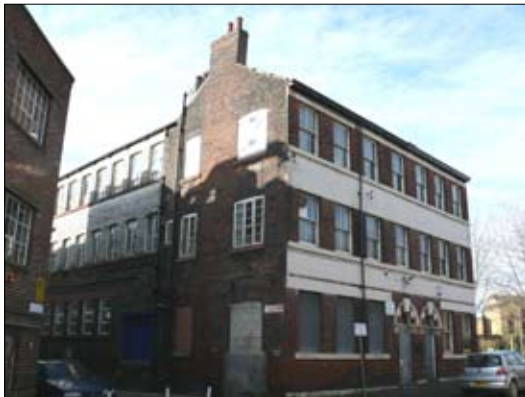
### **Thomas Street – Block J**

Block J was constructed in 1875 and is a three storey brick built building with a slated timber roof.

**Architectural:** The brick façade has inset casement windows and limited architectural decoration on the architrave detailing around the double entrance door on Thomas Street. On the return elevation along Egerton Lane there are panels of white salt glazed bricks.

**Structural:** Block J is generally structurally sound but there is heavy weathering to the facades and they will require re-pointing and repair.

**Summary:** It is recommended that this building is demolished due to the limited architectural content and the restrictions this creates in commercially developing the site. It is recommended that the double architrave to the entrance doors is retained and utilised within the proposed development.

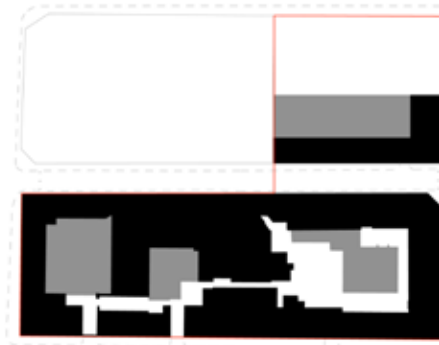
*Existing Figure Ground Study*

The design has been developed to take account of the existing footprint (figure ground) of the Eye Witness and Ceylon Works sites. In doing so it has been a fundamental design philosophy to:

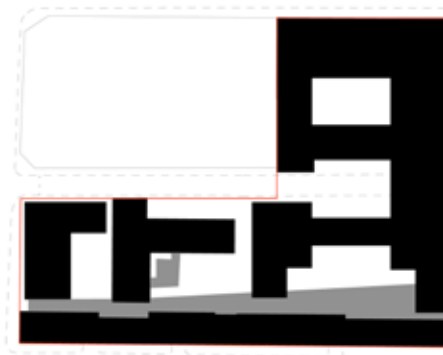
*Proposed Figure Ground Study*

- Reinforce active street frontage to all perimeter facades.
- Introduce series of internal courtyards
- Create linkage to Ceylon Works site.
